**Flood Control Project Maintenance
Levee Inspections**

Fall 2016 Levee Maintenance Deficiency Summary Report

Reclamation District No. 2064 River Junction

Fall 2016 Levee Inspection Results

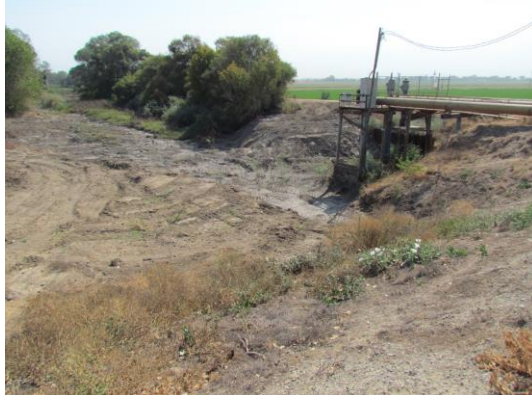
Photo 1 of 1 : FA_2016_RD2064_313_19_20161102_00036.jpg

RD 2064 Looking downstream from levee mile 0.04 Unit 1 landside.

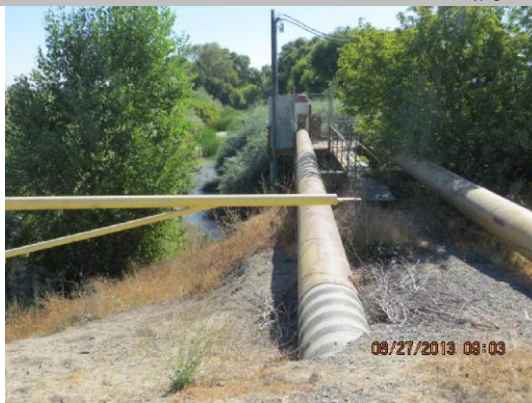
Photo 1 of 2 : UCIP_FA_2016_18718_31286.jpg

LM Start	0.06	Rating **	M	Issue No.	29
LM End	0.06	Issue Type +	En	Location *	LS
Category	Supplemental			GPS Latitude/Longitude	
				Start	End
Item	DWR UCIP Field Study			37.709725 °	37.709725 °
				-121.267534 °	-121.267534 °
DWR ID					
Comment Code					
Inspector Comment					
FS_ID:18718 DS_ID:20512 EP_NO: 13907 Repair Type: Non-Urgent Crossing Status: Found UCIP Comments: This pipe has less than 1-foot of cover. FIELD_STRUCT_DESC: 1 of 3: 24-inch stormdrain discharge pipe through the levee 2.0 feet below the crown (Permit No. 13907, 1985). Two 100-horsepower and one 75-horsepower pumps on landward toe of levee. Siphon breaker on WS shoulder. FS Date: 8/27/2013

Steel storm drain pipe with pump on pier in background.

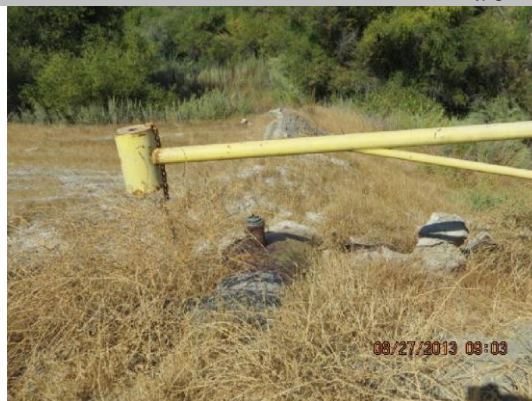
Photo 2 of 2 : UCIP_FA_2016_18718_31285.jpg

LM Start	0.06	Rating **	M	Issue No.	29 (cont)	
LM End	0.06	Issue Type +	En	Location *	LS	
Category	Supplemental			GPS Latitude/Longitude		
				Start	End	
Item	DWR UCIP Field Study			37.709725 °	37.709725 °	
				-121.267534 °	-121.267534 °	
DWR ID						
Comment Code						
Inspector Comment						
FS_ID:18718 DS_ID:20512 EP_NO: 13907 Repair Type: Non-Urgent Crossing Status: Found UCIP Comments: This pipe has less than 1-foot of cover. FIELD_STRUCT_DESC: 1 of 3: 24-inch stormdrain discharge pipe through the levee 2.0 feet below the crown (Permit No. 13907, 1985). Two 100-horsepower and one 75-horsepower pumps on landward toe of levee. Siphon breaker on WS shoulder. FS Date: 8/27/2013

Pipe and siphon breaker visible on WS shoulder.

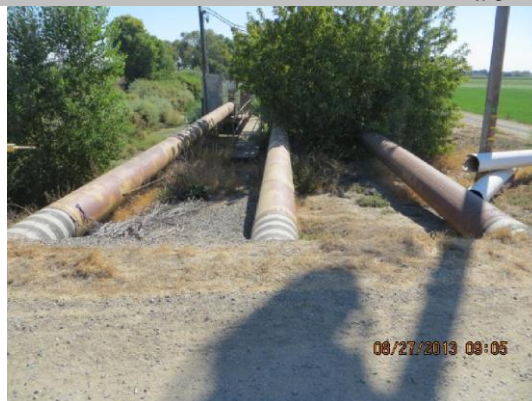
Photo 1 of 2 : UCIP_FA_2016_22729_38458.jpg

LM Start	0.06	Rating **	M	Issue No.	36
LM End	0.06	Issue Type +	En	Location *	LS
Category	Supplemental			GPS Latitude/Longitude	
				Start	End
Item	DWR UCIP Field Study			37.709698 °	37.709698 °
				-121.267536 °	-121.267536 °
DWR ID					
Comment Code					
Inspector Comment					
FS_ID:22729 DS_ID:20527 EP_NO: 13907 Repair Type: Non-Urgent Crossing Status: Found UCIP Comments: This pipe has less than 1-foot of cover. FIELD_STRUCT_DESC: 2 of 3: 24-inch steel stormdrain discharge pipe through the levee 2.0 feet below the crown (Permit No. 13907, 1985). Two 100-horsepower and one 75-horsepower pumps on pier at landward toe of levee. Siphon breaker on WS shoulder. FS Date: 8/27/2013

Pipe visible on LS.

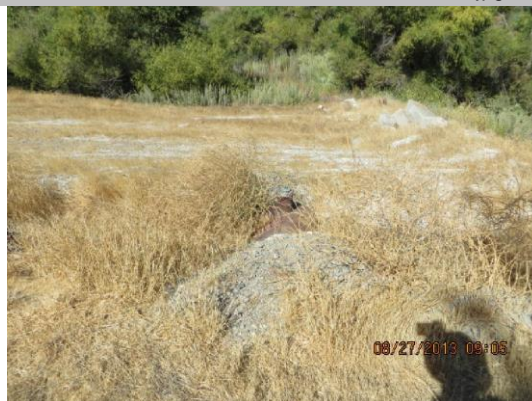
Photo 2 of 2 : UCIP_FA_2016_22729_38457.jpg

LM Start	0.06	Rating **	M	Issue No.	36 (cont)	
LM End	0.06	Issue Type +	En	Location *	LS	
Category	Supplemental			GPS Latitude/Longitude		
				Start	End	
Item	DWR UCIP Field Study			37.709698 °	37.709698 °	
				-121.267536 °	-121.267536 °	
DWR ID						
Comment Code						
Inspector Comment						
FS_ID:22729 DS_ID:20527 EP_NO: 13907 Repair Type: Non-Urgent Crossing Status: Found UCIP Comments: This pipe has less than 1-foot of cover. FIELD_STRUCT_DESC: 2 of 3: 24-inch steel stormdrain discharge pipe through the levee 2.0 feet below the crown (Permit No. 13907, 1985). Two 100-horsepower and one 75-horsepower pumps on pier at landward toe of levee. Siphon breaker on WS shoulder. FS Date: 8/27/2013

Pipe and siphon breaker on WS shoulder.

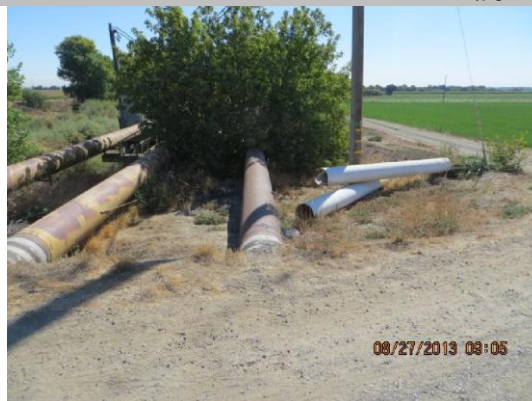
Photo 1 of 2 : UCIP_FA_2016_18720_31294.jpg

LM Start	0.06	Rating **	M	Issue No.	30
LM End	0.06	Issue Type +	En	Location *	LS
Category	Supplemental			GPS Latitude/Longitude	
				Start	End
Item	DWR UCIP Field Study			37.709672 °	37.709672 °
				-121.267532 °	-121.267532 °
DWR ID					
Comment Code					
Inspector Comment					
FS_ID:18720 DS_ID:20528 EP_NO: 13907 Repair Type: Non-Urgent Crossing Status: Found UCIP Comments: This pipe has less than 1-foot of cover. FIELD_STRUCT_DESC: 3 of 3: 24-inch steel stormdrain discharge pipe through the levee 1.0-foot below the crown (Permit No. 13907, 1985). Two 100-horsepower and one 75-horsepower pumps on landward toe of levee. Siphon breaker on WS shoulder. FS Date: 8/27/2013

Steel pipe visible on LS.

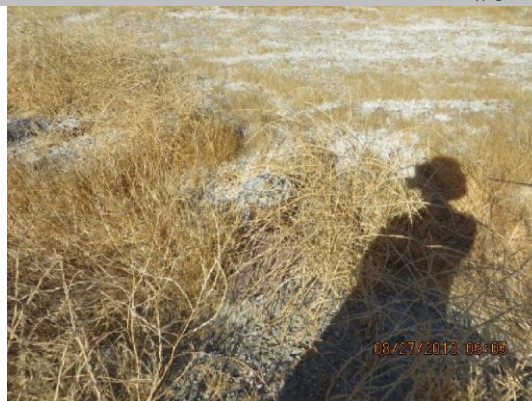
Photo 2 of 2 : UCIP_FA_2016_18720_31293.jpg

LM Start	0.06	Rating **	M	Issue No.	30 (cont)
LM End	0.06	Issue Type +	En	Location *	LS
Category	Supplemental			GPS Latitude/Longitude	
				Start	End
Item	DWR UCIP Field Study			37.709672 °	37.709672 °
				-121.267532 °	-121.267532 °
DWR ID					
Comment Code					
Inspector Comment					
FS_ID:18720 DS_ID:20528 EP_NO: 13907 Repair Type: Non-Urgent Crossing Status: Found UCIP Comments: This pipe has less than 1-foot of cover. FIELD_STRUCT_DESC: 3 of 3: 24-inch steel stormdrain discharge pipe through the levee 1.0-foot below the crown (Permit No. 13907, 1985). Two 100-horsepower and one 75-horsepower pumps on landward toe of levee. Siphon breaker on WS shoulder. FS Date: 8/27/2013

Siphon breaker visible on WS shoulder.

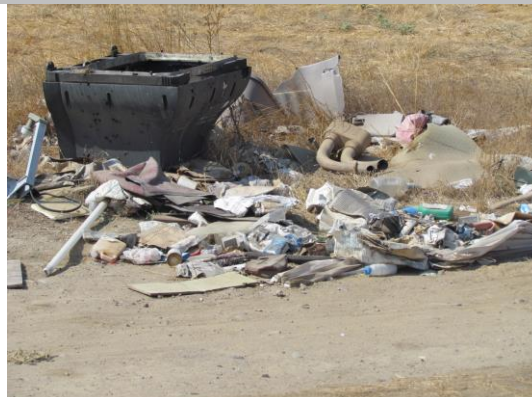
Photo 1 of 1 : FA_2016_RD2064_313_21_20161102_00037.jpg

RD 2064 LOOKING DOWNSTREAM FROM LEVEE MILE 0.90.

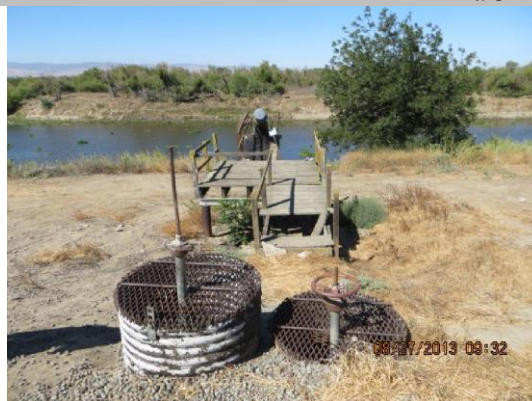
Photo 1 of 2 : UCIP_FA_2016_40792_31377.jpg

LM Start	1.23	Rating **	M	Issue No.	41
LM End	1.23	Issue Type +	En	Location *	WS
Category	Supplemental			GPS Latitude/Longitude	
				Start	End
Item	DWR UCIP Field Study			37.695529 °	37.695529 °
				-121.270005 °	-121.270005 °
DWR ID					
Comment Code					
Inspector Comment					
FS_ID:40792					
DS_ID:20533					
EP_NO: N/A					
Repair Type: Non-Urgent					
Crossing Status: Found					
UCIP Comments: Pump and slant pipe missing from structure on WS slope.					
FIELD_STRUCT_DESC: 12-inch steel concrete encased irrigation pipe through the levee 13.0 feet below the crown, slant pump on the WS toe. Slide gate in 36-inch CMP riser on the WS shoulder. 6'X6' concrete distribution box and filter plant on LS toe. 2-inch galvanized iron electrical conduit at same location. Originally included in the 1968 O&M manual.					
FS Date: 8/27/2013

Slide gate in CMP riser on WS shoulder.

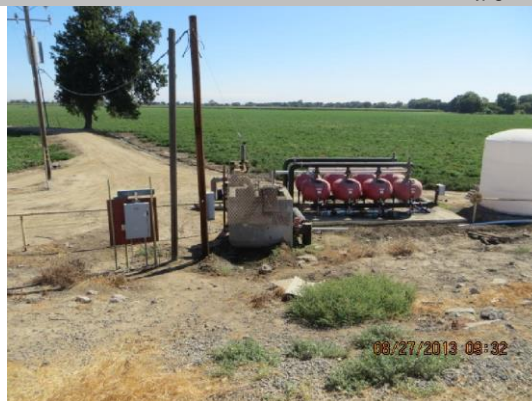
Photo 2 of 2 : UCIP_FA_2016_40792_31376.jpg

LM Start	1.23	Rating **	M	Issue No.	41 (cont)	
LM End	1.23	Issue Type +	En	Location *	WS	
Category	Supplemental			GPS Latitude/Longitude		
				Start		End
Item	DWR UCIP Field Study			37.695529 °	37.695529 °	
				-121.270005 °	-121.270005 °	
DWR ID						
Comment Code						
Inspector Comment						
FS_ID:40792						
DS_ID:20533						
EP_NO: N/A						
Repair Type: Non-Urgent						
Crossing Status: Found						
UCIP Comments: Pump and slant pipe missing from structure on WS slope.						
FIELD_STRUCT_DESC: 12-inch steel concrete encased irrigation pipe through the levee 13.0 feet below the crown, slant pump on the WS toe. Slide gate in 36-inch CMP riser on the WS shoulder. 6'X6' concrete distribution box and filter plant on LS toe. 2-inch galvanized iron electrical conduit at same location. Originally included in the 1968 O&M manual.						
FS Date: 8/27/2013

Concrete distribution box and filter plant on LS toe.

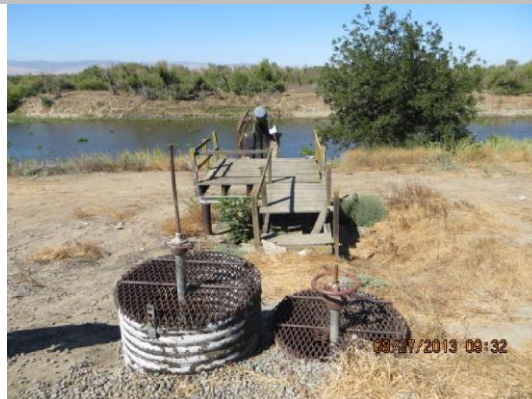
Photo 1 of 2 : UCIP_FA_2016_50998_38462.jpg

FS_ID:50998
DS_ID:20524
EP_NO: 3739
Repair Type: Urgent
Crossing Status: Found
UCIP Comments: 11/16/2016 same as last inspection leak has created sink hole near concrete distribution box located on the LS. Hole in pipe is visible at sink hole. Need to contact owner to address leak on LS. Recommend an internal inspection be completed for the pipe through the levee to determine pipe integrity. (O. Magana - DWR UCIP)08/27/2013 Some leakage at connection between pipe and distro box on LS toe. This may indicate internal failure of pipe. (W. Wylie - DWR UCIP)
FIELD_STRUCT_DESC: 16-inch steel irrigation pipe through the levee, 10.75 feet below the crown. 2-inch galvanized iron electrical conduit at same location. Slant pump is located on the waterside (WS) toe. Slide gate in 36-inch corrugated metal pipe (CMP) riser is located on the WS shoulder. 6-foot by 6-foot concrete distribution box and filter plant are located on landside (LS) toe. (16-inch pipe authorized under Permit No. 3739, 1961 - Mortensen & Barker)

Slant pump on WS toe. Slide gate in 36-inch CMP riser on WS shoulder.

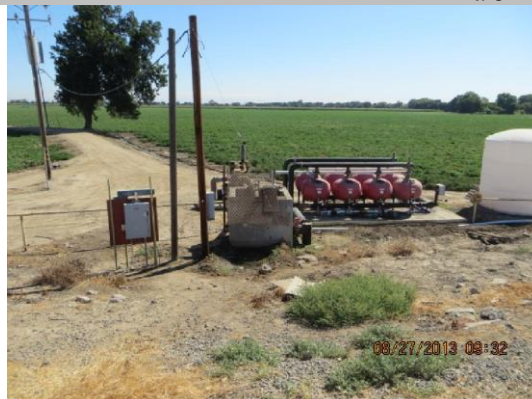
Photo 2 of 2 : UCIP_FA_2016_50998_38461.jpg

Concrete distribution box on LS toe with filter plant.

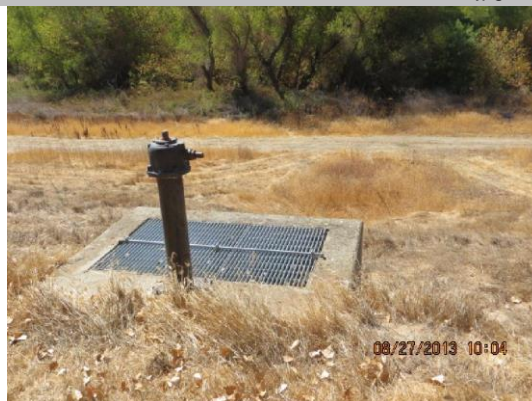
Photo 1 of 2 : UCIP_FA_2016_18763_31402.jpg

LM Start	1.94	Rating **	M	Issue No.	28
LM End	1.94	Issue Type +	En	Location *	WS
Category	Supplemental			GPS Latitude/Longitude	
				Start	End
Item	DWR UCIP Field Study			37.689900 °	37.689900 °
				-121.264802 °	-121.264802 °
DWR ID					
Comment Code					
Inspector Comment					
FS_ID:18763					
DS_ID:20515					
EP_NO: N/A					
Repair Type: Non-Urgent					
Crossing Status: Found					
UCIP Comments: Culvert filled nearly to the top with soil.					
FIELD_STRUCT_DESC: 30-inch square reinforced concrete stormdrain					
box culvert through the levee 14.7-feet below the crown. Slide gate in					
concrete riser unit on the waterward slope. Concrete "U" shaped					
headwalls on both ends. Flap gate on the waterward end. Originally					
included in the 1968 O&M manual.					
FS Date: 8/27/2013

Slide gate in Concrete riser on WS shoulder.

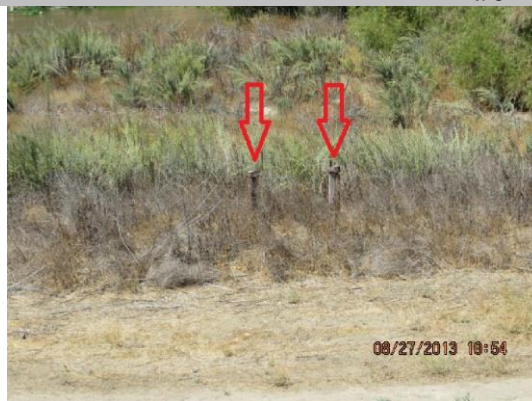
Photo 1 of 1 : UCIP_FA_2016_22731_38463.jpg

LM Start	3.46	Rating **	M	Issue No.	37
LM End	3.46	Issue Type +	En	Location *	WS
Category	Supplemental			GPS Latitude/Longitude	
				Start	End
Item	DWR UCIP Field Study			37.676751 °	37.676751 °
				-121.264193 °	-121.264193 °
DWR ID					
Comment Code					
Inspector Comment					
FS_ID:22731 DS_ID:20517 EP_NO: N/A Repair Type: Non-Urgent Crossing Status: Indicator Found UCIP Comments: Neet to verify status of pipeline. FIELD_STRUCT_DESC: Underground gas line crossing; depth through the levee and size unknown. Found possible sign posts on WS toe. FS Date: 8/27/2013

Possible sign posts on WS toe.

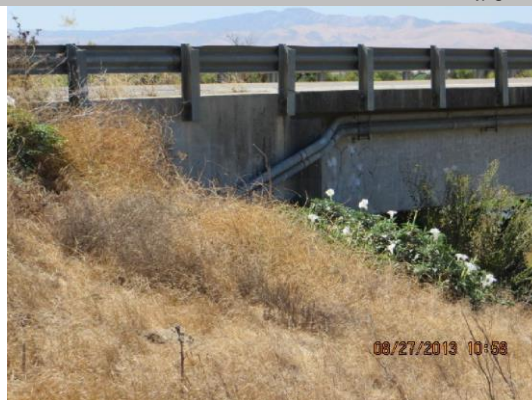
Photo 1 of 1 : UCIP_FA_2016_22085_37702.jpg

LM Start	3.49	Rating **	M	Issue No.	31
LM End	3.49	Issue Type +	En	Location *	WS
Category	Supplemental			GPS Latitude/Longitude	
				Start	End
Item	DWR UCIP Field Study			37.676276 °	37.676276 °
				-121.264104 °	-121.264104 °
DWR ID					
Comment Code					
Inspector Comment					
FS_ID:22085 DS_ID:24059 EP_NO: N/A Repair Type: Non-Urgent Crossing Status: Found UCIP Comments: Unable to identify purpose or permit for this crossing. FIELD_STRUCT_DESC: 1 of 2: 4-inch galvanized iron conduit through the levee at unknown depth below the crown. Visible on downstream side of the bridge. 3.5-foot by 6-foot steel vault on crown. FS Date: 8/27/2013

Upper conduit visible on DS side of bridge.

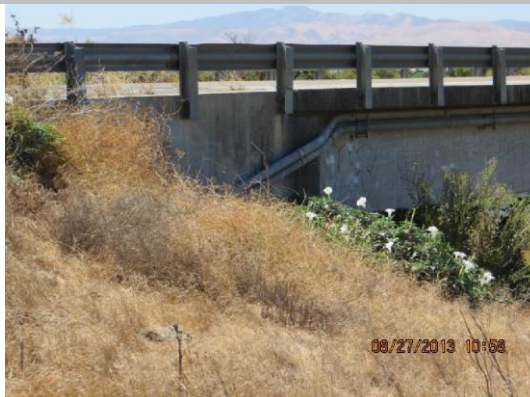
Photo 1 of 1 : UCIP_FA_2016_22790_38826.jpg

LM Start	3.49	Rating **	M	Issue No.	40
LM End	3.49	Issue Type +	En	Location *	WS
Category	Supplemental			GPS Latitude/Longitude	
				Start	End
Item	DWR UCIP Field Study			37.676276 °	37.676276 °
				-121.264104 °	-121.264104 °
DWR ID					
Comment Code					
Inspector Comment					
FS_ID:22790 DS_ID:24060 EP_NO: N/A Repair Type: Non-Urgent Crossing Status: Found UCIP Comments: Unable to identify purpose or permit for this crossing. FIELD_STRUCT_DESC: 2 of 2: 4-inch galvanized iron conduit through the levee at unknown depth below the crown. Visible on downstream side of the bridge. 3.5-foot by 6-foot steel vault on crown. FS Date: 8/27/2013

Lower conduit visible on DS side of bridge at WS slope.

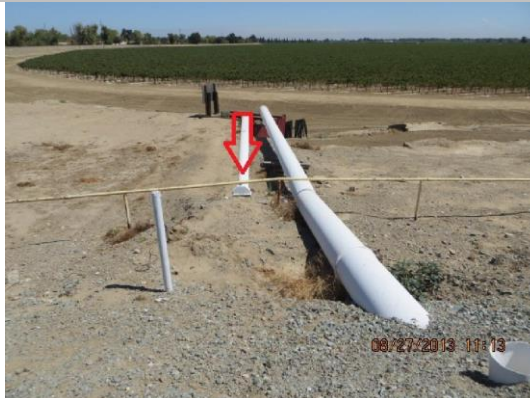
Photo 1 of 2 : UCIP_FA_2016_19044_31844.jpg

LM Start	3.57	Rating **	M	Issue No.	32
LM End	3.57	Issue Type +	En	Location *	WS
Category	Supplemental			GPS Latitude/Longitude	
				Start	End
Item	DWR UCIP Field Study			37.675267 °	37.675267 °
				-121.263426 °	-121.263426 °
DWR ID					
Comment Code					
Inspector Comment					
FS_ID:19044 DS_ID:20519 EP_NO: 6450 Repair Type: Non-Urgent Crossing Status: Found UCIP Comments: Appears abandoned and if so should be done so properly. FIELD_STRUCT_DESC: *ABANDONED* 18-inch steel discharge pipe through the levee 2-feet below the crown. Crown roadway padded over the pipe. Pipe exposed on both slopes. Gate valve on the LS toe. Pump missing from sump with sheet pile siding in ditch on the landside. Siphon breaker on the waterward side (Permit No. 6450, 1969). FS Date: 8/27/2013

Pipe and gate valve on LS toe.

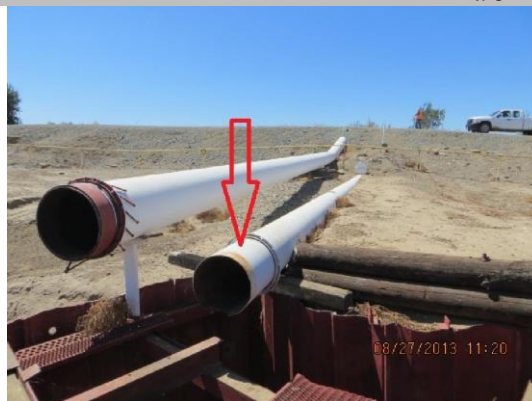
Photo 2 of 2 : UCIP_FA_2016_19044_31843.jpg

LM Start	3.57	Rating **	M	Issue No.	32 (cont)	
LM End	3.57	Issue Type +	En	Location *	WS	
Category	Supplemental			GPS Latitude/Longitude		
				Start		End
Item	DWR UCIP Field Study			37.675267 °		37.675267 °
				-121.263426 °		-121.263426 °
DWR ID						
Comment Code						
Inspector Comment						
FS_ID:19044 DS_ID:20519 EP_NO: 6450 Repair Type: Non-Urgent Crossing Status: Found UCIP Comments: Appears abandoned and if so should be done so properly. FIELD_STRUCT_DESC: *ABANDONED* 18-inch steel discharge pipe through the levee 2-feet below the crown. Crown roadway padded over the pipe. Pipe exposed on both slopes. Gate valve on the LS toe. Pump missing from sump with sheet pile siding in ditch on the landside. Siphon breaker on the waterward side (Permit No. 6450, 1969). FS Date: 8/27/2013

Pipe visible at sump off LS toe. No pump or appurtenances.

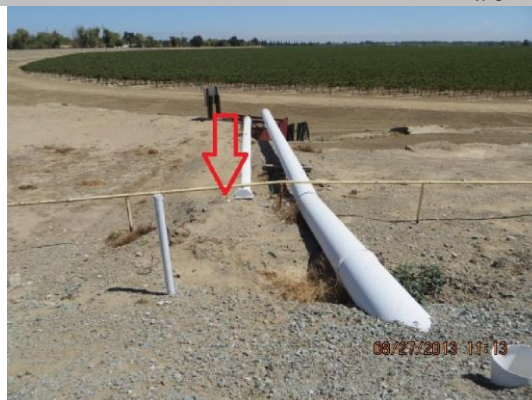
Photo 1 of 2 : UCIP_FA_2016_22732_38465.jpg

LM Start	3.57	Rating **	M	Issue No.	38
LM End	3.57	Issue Type +	En	Location *	WS
Category	Supplemental			GPS Latitude/Longitude	
				Start	End
Item	DWR UCIP Field Study			37.675266 °	37.675266 °
				-121.263421 °	-121.263421 °
DWR ID					
Comment Code					
Inspector Comment					
FS_ID:22732					
DS_ID:20525					
EP_NO: N/A					
Repair Type: Non-Urgent					
Crossing Status: Found					
UCIP Comments: Need to determine if pipe was actually removed from levee.					
FIELD_STRUCT_DESC: 12-inch steel stormdrain pipe through the levee at unknown depth below the crown. Steel plate welded over LS end at LS toe. Permit No. 6450, states it was removed in 1973, but it remains visible on the LS toe. Originally included in the 1968 O&M manual.					
FS Date: 8/27/2013

Pipe visible on LS toe.

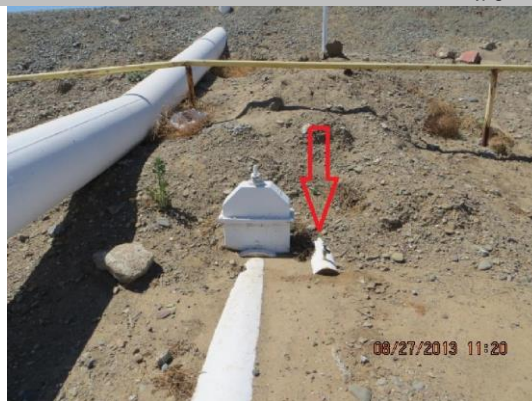
Photo 2 of 2 : UCIP_FA_2016_22732_38464.jpg

LM Start	3.57	Rating **	M	Issue No.	38 (cont)	
LM End	3.57	Issue Type +	En	Location *	WS	
Category	Supplemental			GPS Latitude/Longitude		
				Start	End	
Item	DWR UCIP Field Study			37.675266 °	37.675266 °	
				-121.263421 °	-121.263421 °	
DWR ID						
Comment Code						
Inspector Comment						
FS_ID:22732 DS_ID:20525 EP_NO: N/A Repair Type: Non-Urgent Crossing Status: Found UCIP Comments: Need to determine if pipe was actually removed from levee. FIELD_STRUCT_DESC: 12-inch steel stormdrain pipe through the levee at unknown depth below the crown. Steel plate welded over LS end at LS toe. Permit No. 6450, states it was removed in 1973, but it remains visible on the LS toe. Originally included in the 1968 O&M manual. FS Date: 8/27/2013

Pipe with welded steel plate over LS end at LS toe.

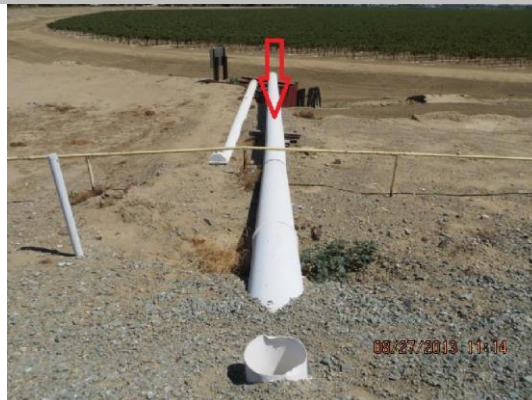
Photo 1 of 2 : UCIP_FA_2016_22733_38468.jpg

LM Start	3.57	Rating **	M	Issue No.	39
LM End	3.57	Issue Type +	En	Location *	WS
Category	Supplemental			GPS Latitude/Longitude	
				Start	End
Item	DWR UCIP Field Study			37.675247 °	37.675247 °
				-121.263398 °	-121.263398 °
DWR ID					
Comment Code					
Inspector Comment					
FS_ID:22733					
DS_ID:20522					
EP_NO: 13609					
Repair Type: Non-Urgent					
Crossing Status: Found					
UCIP Comments: Appears abandoned and should be done so properly. Pipe was to be removed in 1984.					
FIELD_STRUCT_DESC: *ABANDONED* 1 of 2: 24-inch steel discharge pipe through the levee 2-feet below the crown (Permit No. 13609, 1983). Approx. 420 feet upstream of Durham Ferry-Airport Way Road.					
FS Date: 8/27/2013

Pipe and vent visible on LS slope.

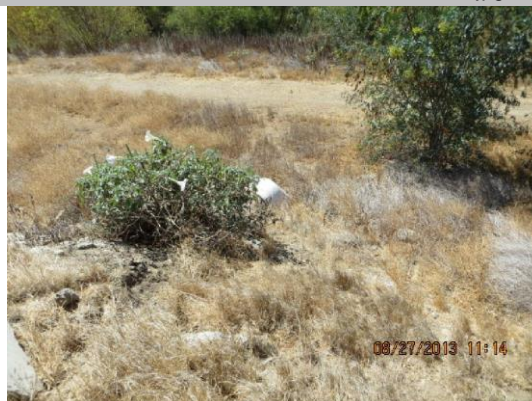
Photo 2 of 2 : UCIP_FA_2016_22733_38467.jpg

LM Start	3.57	Rating **	M	Issue No.	39 (cont)	
LM End	3.57	Issue Type +	En	Location *	WS	
Category	Supplemental			GPS Latitude/Longitude		
				Start	End	
Item	DWR UCIP Field Study			37.675247 °	37.675247 °	
				-121.263398 °	-121.263398 °	
DWR ID						
Comment Code						
Inspector Comment						
FS_ID:22733 DS_ID:20522 EP_NO: 13609 Repair Type: Non-Urgent Crossing Status: Found UCIP Comments: Appears abandoned and should be done so properly. Pipe was to be removed in 1984. FIELD_STRUCT_DESC: *ABANDONED* 1 of 2: 24-inch steel discharge pipe through the levee 2-feet below the crown (Permit No. 13609, 1983). Approx. 420 feet upstream of Durham Ferry-Airport Way Road. FS Date: 8/27/2013

Pipe visible on WS slope.

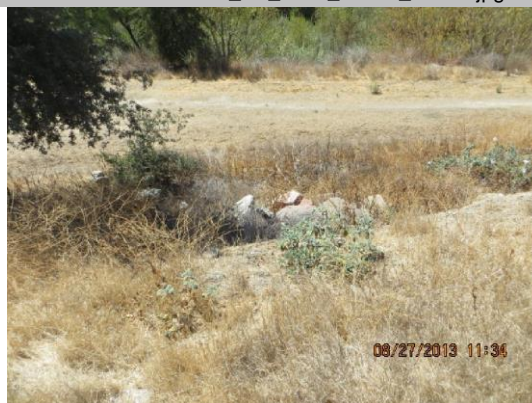
Photo 1 of 2 : UCIP_FA_2016_19046_31849.jpg

LM Start	3.60	Rating **	M	Issue No.	33
LM End	3.60	Issue Type +	En	Location *	WS
Category	Supplemental			GPS Latitude/Longitude	
				Start	End
Item	DWR UCIP Field Study			37.675005 °	37.675005 °
				-121.263103 °	-121.263103 °
DWR ID					
Comment Code					
Inspector Comment					
FS_ID:19046 DS_ID:20534 EP_NO: 13609 Repair Type: Non-Urgent Crossing Status: Indicator Found UCIP Comments: Pipes should be abandoned properly. FIELD_STRUCT_DESC: 2 of 2: *REMOVED* 24-inch steel pipe through levee 12.67 feet below crown (Permit No. 13609, 1983). Approx. 75 feet upstream of first 24-inch pipe. According to notes in permit, Concrete rubble was placed over pipe on WS slope. FS Date: 8/27/2013

Concrete rubble on WS slope possible indicator of abandoned pipe location.

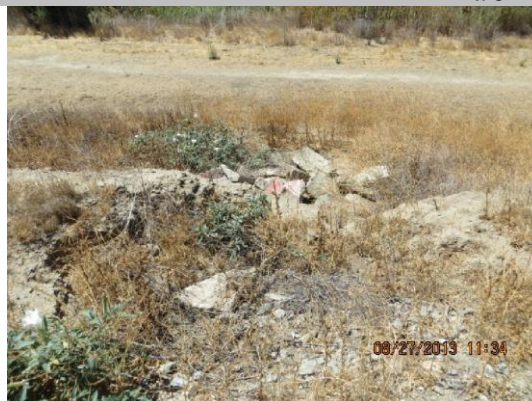
Photo 2 of 2 : UCIP_FA_2016_19046_31848.jpg

LM Start	3.60	Rating **	M	Issue No.	33 (cont)	
LM End	3.60	Issue Type +	En	Location *	WS	
Category	Supplemental			GPS Latitude/Longitude		
				Start	End	
Item	DWR UCIP Field Study			37.675005 °	37.675005 °	
				-121.263103 °	-121.263103 °	
DWR ID						
Comment Code						
Inspector Comment						
FS_ID:19046 DS_ID:20534 EP_NO: 13609 Repair Type: Non-Urgent Crossing Status: Indicator Found UCIP Comments: Pipes should be abandoned properly. FIELD_STRUCT_DESC: 2 of 2: *REMOVED* 24-inch steel pipe through levee 12.67 feet below crown (Permit No. 13609, 1983). Approx. 75 feet upstream of first 24-inch pipe. According to notes in permit, Concrete rubble was placed over pipe on WS slope. FS Date: 8/27/2013

Concrete rubble on WS slope possible indicator of abandoned pipe location.

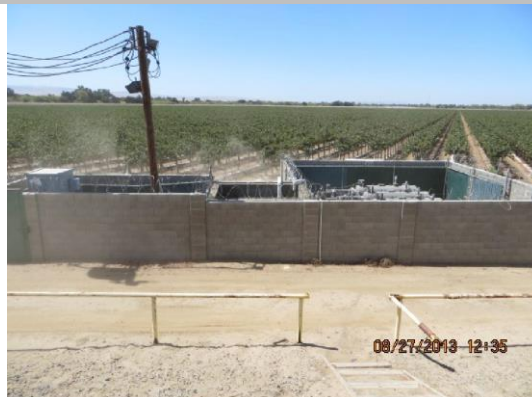
Photo 1 of 2 : UCIP_FA_2016_19063_31861.jpg

LM Start	4.72	Rating **	M	Issue No.	34
LM End	4.72	Issue Type +	En	Location *	LS
Category	Supplemental			GPS Latitude/Longitude	
				Start	End
Item	DWR UCIP Field Study			37.670161 °	37.670161 °
				-121.246973 °	-121.246973 °
DWR ID					
Comment Code					
Inspector Comment					
FS_ID:19063 DS_ID:20520 EP_NO: 3359 Repair Type: Non-Urgent Crossing Status: Indicator Found UCIP Comments: Pipe not found. Need to determine disposition of pipe as all other appurtances remain. FIELD_STRUCT_DESC: 1 of 2: 24-inch pipe through the levee 3.5 feet below the crown (Permit No. 3359, 1961). Pump mounted on pipe structure in the river; protective fender in the stream, wooden walkway to the pump structure. Siphon breaker on the landward side. Originally included in the 1968 O&M manual. FS Date: 8/27/2013

Concrete distribution box remains in center of structure on LS toe.

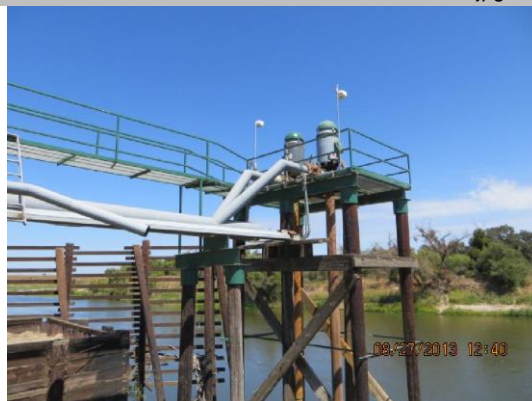
Photo 2 of 2 : UCIP_FA_2016_19063_31860.jpg

Pump platform, walkway, and fender remain in stream. No 24-inch pipe found.

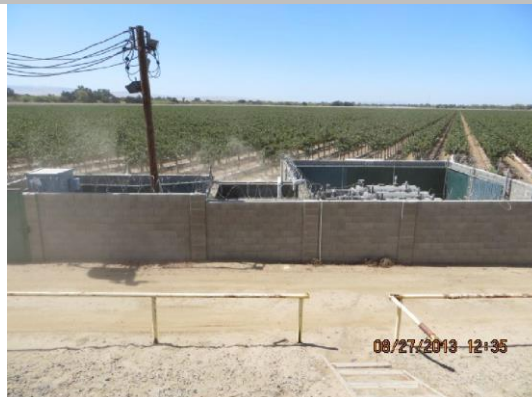
Photo 1 of 2 : UCIP_FA_2016_19064_31863.jpg

LM Start	4.72	Rating **	M	Issue No.	35
LM End	4.72	Issue Type +	En	Location *	LS
Category	Supplemental			GPS Latitude/Longitude	
				Start	End
Item	DWR UCIP Field Study			37.670161 °	37.670161 °
				-121.246973 °	-121.246973 °
DWR ID					
Comment Code					
Inspector Comment					
FS_ID:19064 DS_ID:20530 EP_NO: 3359 Repair Type: Non-Urgent Crossing Status: Indicator Found UCIP Comments: Pipe not found. Need to determine disposition of pipe as all other appurtances remain. FIELD_STRUCT_DESC: 2 of 2: 18-inch pipe through levee 3.5 feet below the crown (Permit No. 3359, 1961). Pump mounted on pipe structure in the river; protective fender in the stream, wooden walkway to the pump structure. Siphon breaker on the landward side. Originally included in the 1968 O&M manual. FS Date: 8/27/2013

Concrete distribution box in center of structure on LS toe.

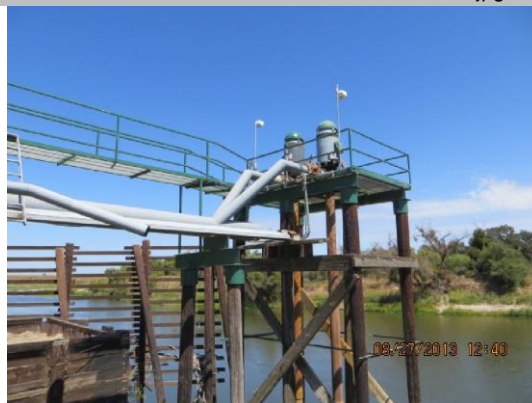
Photo 2 of 2 : UCIP_FA_2016_19064_31862.jpg

Pump platform and fender visible on WS toe.

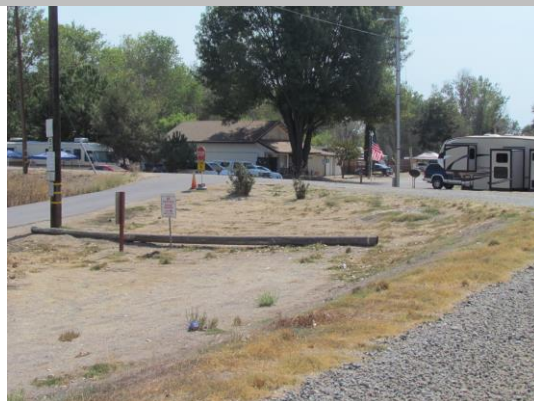
Photo 1 of 1 : FA_2016_RD2064_314_16_20161102_00027.jpg

RD 2064 Unit 2 looking downstream from levee mile 0.00 landside slope.

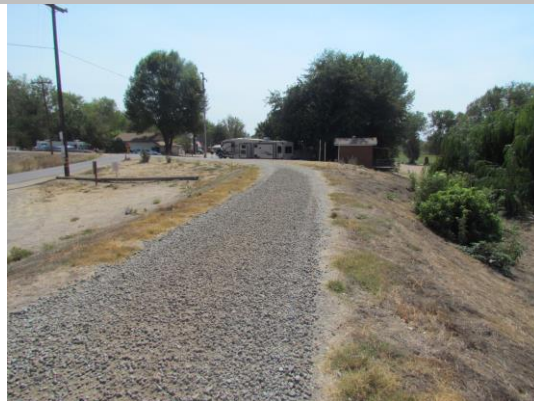
Photo 1 of 1 : FA_2016_RD2064_314_15_20161102_00028.jpg

RD2064 Looking downstream from levee 0.01 waterside slope.

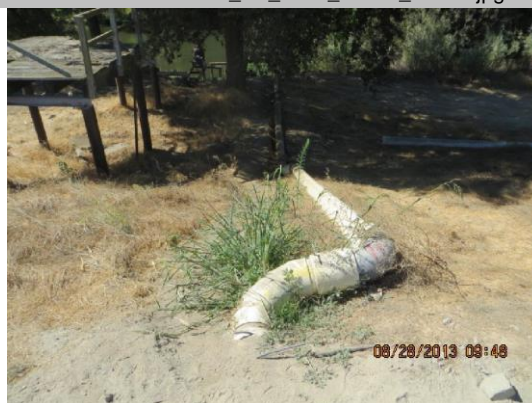
Photo 2 of 2 : UCIP_FA_2016_44653_37714.jpg

LM Start	0.33	Rating **	M	Issue No.	31
LM End	0.33	Issue Type +	En	Location *	WS
Category	Supplemental			GPS Latitude/Longitude	
				Start	End
Item	DWR UCIP Field Study			37.664752 °	37.664752 °
				-121.236512 °	-121.236512 °
DWR ID					
Comment Code					
Inspector Comment					
FS_ID:44653					
DS_ID:24062					
EP_NO: N/A					
Repair Type: Non-Urgent					
Crossing Status: Found					
UCIP Comments: Plan of action in progress to install permanant pipe and pump by August 2015. No permit identified for large PVC irrigation pipe with inadequate cover.					
FIELD_STRUCT_DESC: 8-inch PVC irrigation pipe through the levee 0.5-feet below the crown. Portable pump on the WS berm and a filter plant on the LS toe. Vent at filter plant on LS toe.					
FS Date: 4/22/2015

Pipe visible on WS shoulder/slope.

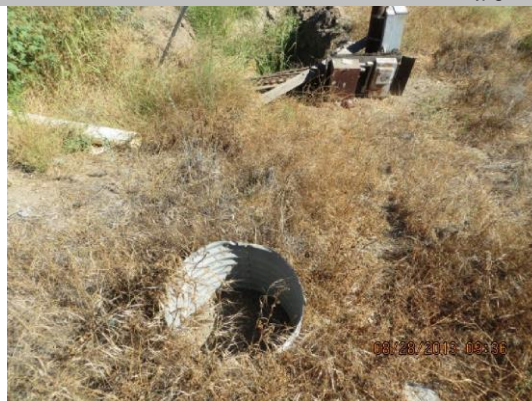
Photo 1 of 2 : UCIP_FA_2016_50758_31892.jpg

FS_ID:50758
DS_ID:20537
EP_NO: 4462
Repair Type: Non-Urgent
Crossing Status: Found
UCIP Comments: 11/16/2016 Crossing has been downgraded from Urgent to Non-Urgent pipe has been grouted and new pipe installed however, no permit is currently available to document work. Need to contact owner to determine permit authorizing existing pipe to be grouted and new pipe to be installed. (O. Magana - DWR UCIP)08/28/2013 Pipe failing on LS toe do to excessive rust. Pump missing from deteriorating wooden platform on LS slope. Pipe crossing being repaired at site. (W. Wylie - DWR UCIP)
FIELD_STRUCT_DESC: *ABANDONED* 16-inch steel irrigation pipe through the levee, 3.5 feet below the crown. 2-inch electrical conduit through levee. Slant pump is located on the waterside (WS) bank. Siphon breaker is located on the landside (LS) shoulder. Timber walkway from the levee slope to the pump motor is located on the WS. Pump, motor, and walkway have been removed as of 2016. Siphon breaker and grouted pipe still remain at this location as of 2016. (16-inch pipe authorized under Permit No. 4462, 1964 - Ball). [Additional Reference(s): DWR Levee Log, 2005. USACE San Joaquin River O&M Manual Unit No. 3, December 1968, (HLM 0.33), Drawing No. 7-4-1685, sheet 1685/58, station 307+57A].

Siphon breaker in 24-inch CMP riser on LS shoulder.

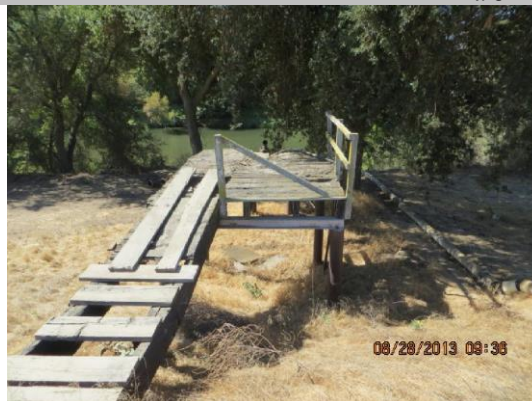
Photo 2 of 2 : UCIP_FA_2016_50758_31891.jpg

Deteriorated wooded pump platform on WS shoulder.

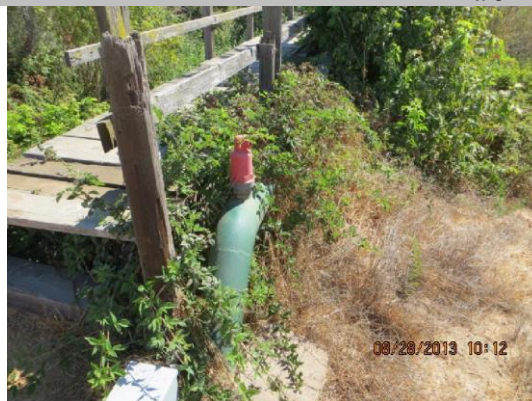
Photo 1 of 2 : UCIP_FA_2016_22095_37722.jpg

FS_ID:22095
DS_ID:24063
EP_NO: N/A
Repair Type: Non-Urgent
Crossing Status: Found
UCIP Comments: No permit identified for this crossing.
FIELD_STRUCT_DESC: 6-inch steel irrigation pipe through the levee at unknown depth below the crown. Pump on wooden pier at WS . Vent between 2 steel bollards on LS shoulder. Filter plant on LS toe. 1.5-inch galvanized iron electrical conduit at same location.
FS Date: 8/27/2013

Pipe and vent visible on WS shoulder at wooden walkway.

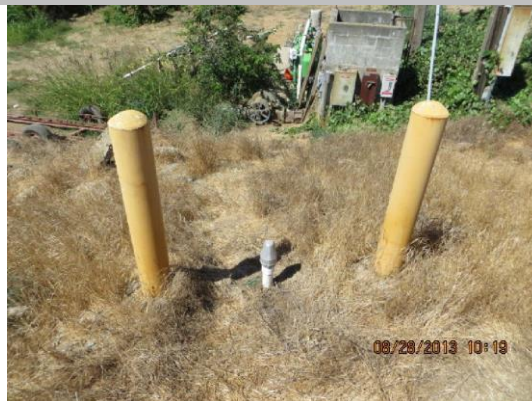
Photo 2 of 2 : UCIP_FA_2016_22095_37721.jpg

Vent on LS shoulder.

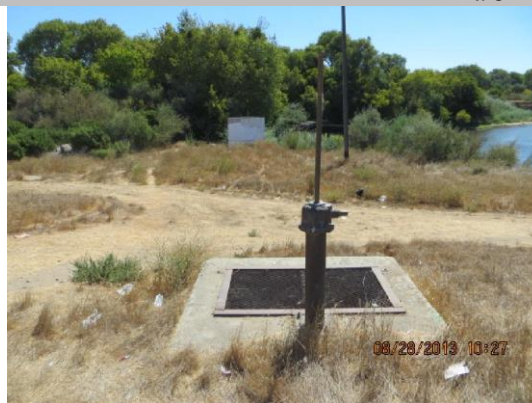
Photo 1 of 2 : UCIP_FA_2016_19086_31954.jpg

Comment Code					
Inspector Comment					
FS_ID:19086					
DS_ID:20540					
EP_NO: N/A					
Repair Type: Non-Urgent					
Crossing Status: Found					
UCIP Comments: Leak next to roadway may indicate pipe has reached life capacity-good candidate for video inspection.					
FIELD_STRUCT_DESC: 30-inch reinforced concrete box culvert through the levee 14.5-feet below the crown. Pipe reduced to 24-inch through the berm to pump house. Slide gate in 6'X7' concrete riser unit on the waterward slope. Slant pump mounted on WS berm next to 5'X9' concrete riser. 1.5-inch electrical conduit at same location. Originally included in the 1968 O&M manual.					
FS Date: 8/28/2013

Gate valve on WS shoulder. Pump next to concrete riser in background.

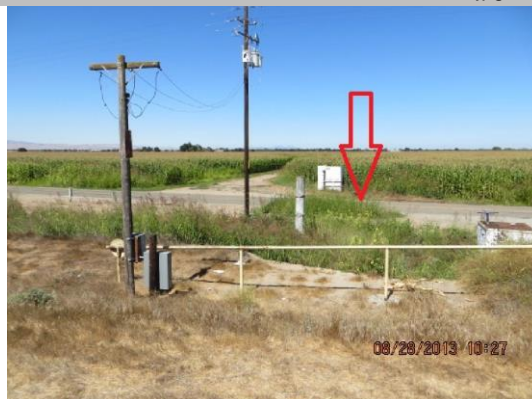
Photo 2 of 2 : UCIP_FA_2016_19086_31953.jpg

Comment Code						
Inspector Comment						
FS_ID:19086						
DS_ID:20540						
EP_NO: N/A						
Repair Type: Non-Urgent						
Crossing Status: Found						
UCIP Comments: Leak next to roadway may indicate pipe has reached life capacity-good candidate for video inspection.						
FIELD_STRUCT_DESC: 30-inch reinforced concrete box culvert through the levee 14.5-feet below the crown. Pipe reduced to 24-inch through the berm to pump house. Slide gate in 6'X7' concrete riser unit on the waterward slope. Slant pump mounted on WS berm next to 5'X9' concrete riser. 1.5-inch electrical conduit at same location. Originally included in the 1968 O&M manual.						
FS Date: 8/28/2013

Wet area next to roadway off LS toe may indicate a leak. Power pole and meter on LS toe.

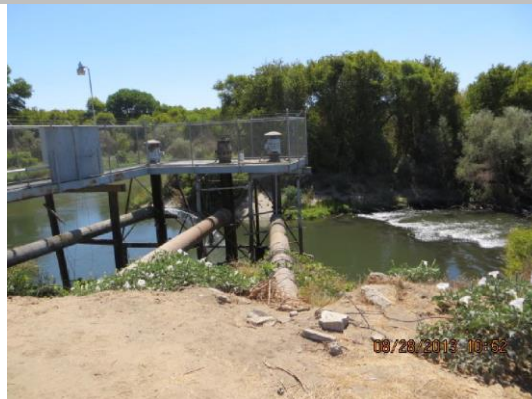
Photo 1 of 2 : UCIP_FA_2016_41075_31963.jpg

Pipe and pump visible on WS berm.

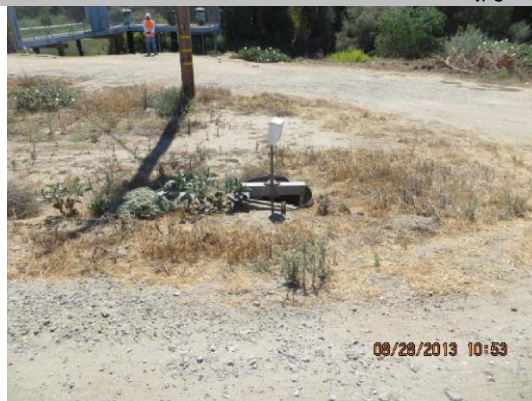
Photo 2 of 2 : UCIP_FA_2016_41075_31962.jpg

Slide gate in 36-inch CMP riser on WS slope.

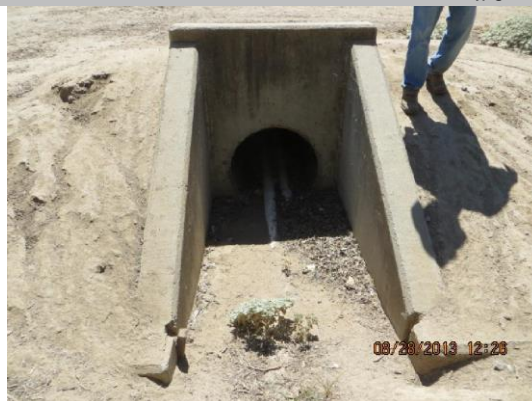
Photo 1 of 2 : UCIP_FA_2016_22108_37739.jpg

PVC pipe at right inside stormdrain on LS toe.

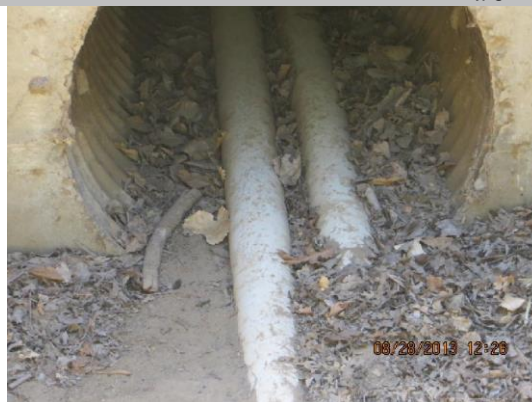
Photo 2 of 2 : UCIP_FA_2016_22108_37738.jpg

PVC pipe at right inside stormdrain on LS toe.

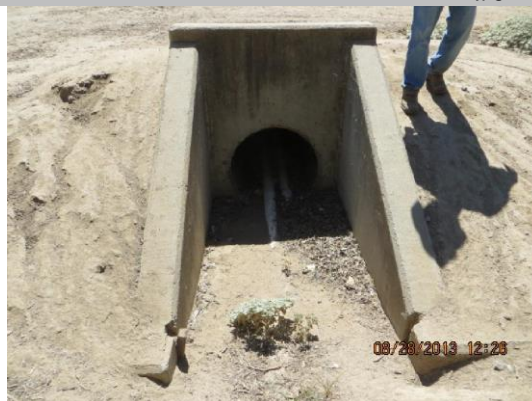
Photo 1 of 2 : UCIP_FA_2016_22109_37742.jpg

PVC conduit at left on LS toe.

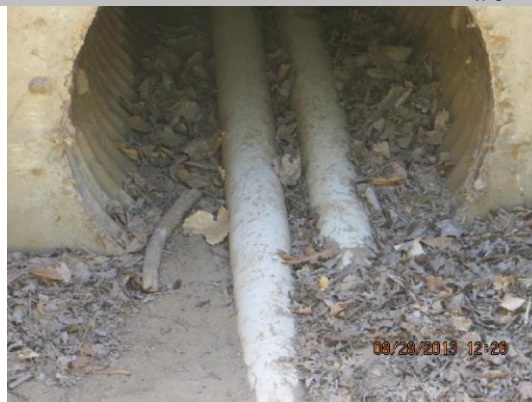
Photo 2 of 2 : UCIP_FA_2016_22109_37741.jpg

PVC conduit at left on LS toe.

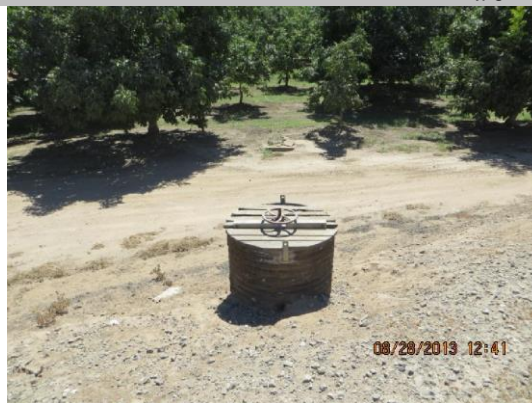
Photo 1 of 2 : UCIP_FA_2016_19145_32126.jpg

Slide gate in CMP riser on WS slope

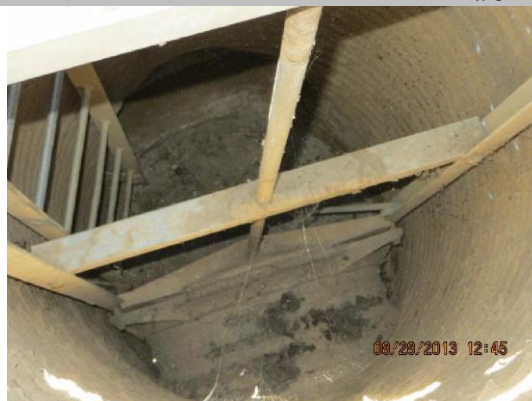
Photo 2 of 2 : UCIP_FA_2016_19145_32125.jpg

Pipe in CMP riser on WS slope.

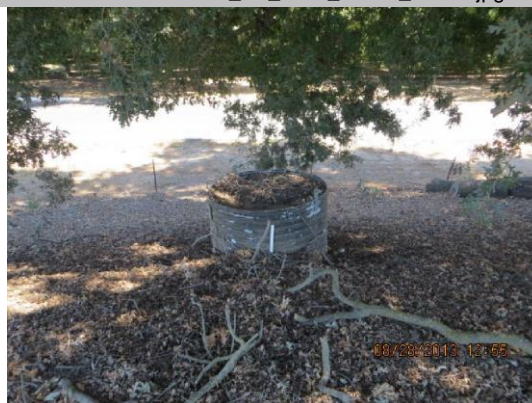
Photo 1 of 1 : UCIP_FA_2016_19146_32127.jpg

CMP riser for slide gate filled with soil.
